Manhole Inspection Summary

Manhole # S41KK_034MH

Insp Date: **1/23/08 9:39 AM**

Location Address: **BEHIND 1333 NORTH AVE**

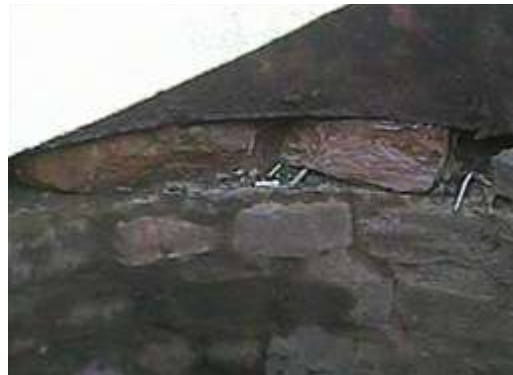
Defect 1

Condition: ☐ Sound ☐ Cracked ☐ Root Intrusion ☒ **Loose Brick** ☒ **Deteriorated**

CHIMNEY LOOSE BRICKS

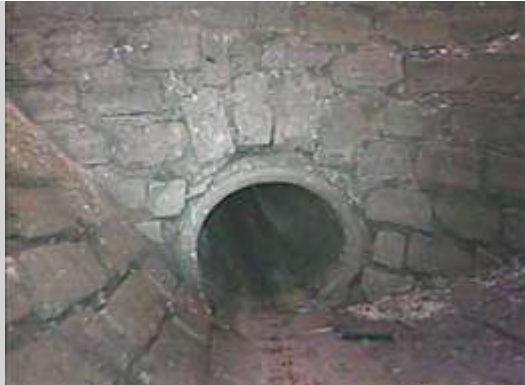
12 O'Clock Outflow

8 in. Circular Gravity Sewer
Pipe Out @ 12 O'Clock

Infiltration: **None** Pipe Seal Cond: **Sound**

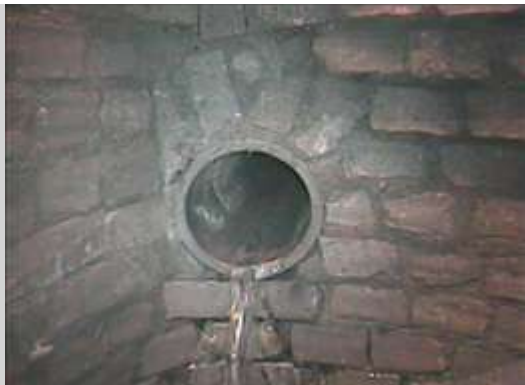
6 O'Clock Inflow

6 in. Circular Gravity Sewer
Pipe In @ 6 O'Clock

Infiltration: **None** Pipe Seal Cond: **Sound**
